WT-1131

Operation TEAPOT

Project 3.9

RESPONSE OF SMALL PETROLEUM PRODUCTS STORAGE TANKS

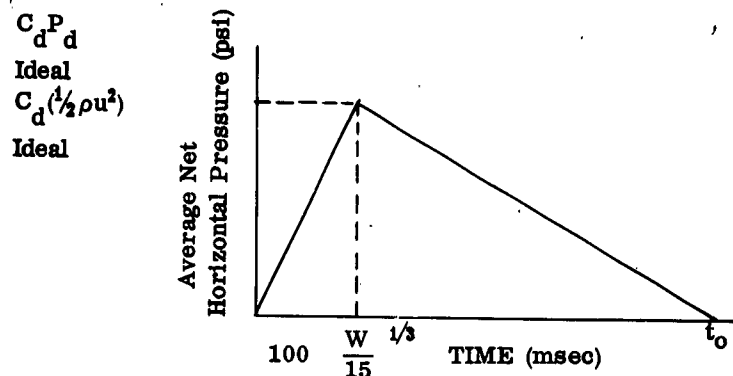
Figure 2.1 Schematic loading scheme in a precursor.

The vertical loadings in precursor regions are equally uncertain. For these computations, the ratio of the maximum vertical pressure to the peak free stream pressure was assumed to be constant. This assumption was based on rather inconclusive evidence from Project 3.1 in Shot 10 of Upshot-Knothole. This ratio varied from approximately 0.38 (for an overpressure of 50 psi) to 0.72 (for an overpressure of 8 psi). For lack of more detailed information, the vertical pressures were assumed to be approximately 50 percent of the free-stream pressure.

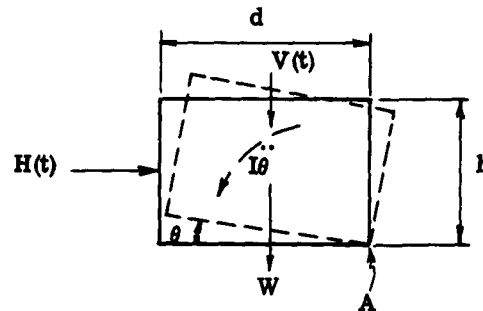
Figure 2.2 Overturning of tank about A.

The equation of motion is: $\frac{h}{2} H(t) = I\ddot{\theta} + \frac{[V(t) + W]d}{2}$

The first mode of failure considered was that at which the tank would start to overturn as a rigid body about one edge (see Figure 2.2). When considering overturning, it was felt that only the initiation of overturning was of interest, since failure of the tank bottom would be expected with very small movements. Computations showed that a slight uplift of the ground-zero side of the tanks would occur if the filled tanks were placed at approximately 1,000 feet from ground zero. This calculation of the incipient uplift was based on the resistance to overturning provided by the weight of the tank, the weight of water, and the assumed vertical loading. Incipient overturning would be associated with the predicted peak horizontal loading.

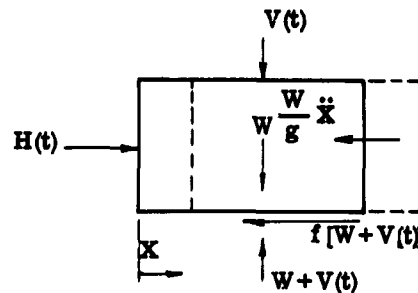
Figure 2.3 Sliding of tank.

The equation of motion is: $\frac{W}{g} \ddot{X} + f [W + V(t)] = H(t)$

The second type of rigid-body motion considered was sliding due to the horizontal forces (see Figure 2.3). Sliding is resisted by frictional forces developed between the bottom of the tanks and the sand. This resistance is dependent upon the coefficient of friction and on the vertical forces between the tank and sand. The vertical forces consist of weight of the tank, the weight of the water, and the vertical blast loading. Incipient sliding would be associated with the peak horizontal loading. For any test, the frictional resistance between the tank and sand is highly uncertain. If movement occurs, the tank might dig into the sand and thereby be restrained from further sliding; in effect, the coefficient of friction would be increased. If the coefficient of friction is assumed to be unity, sliding would occur at distances from ground zero of less than 1,300 feet. If the coefficient of friction is 0.5, the distance increases to approximately 1,600 feet. There is no practical method for prediction of sliding, plowing up of a ridge, and overturning about the ridge as a fulcrum.

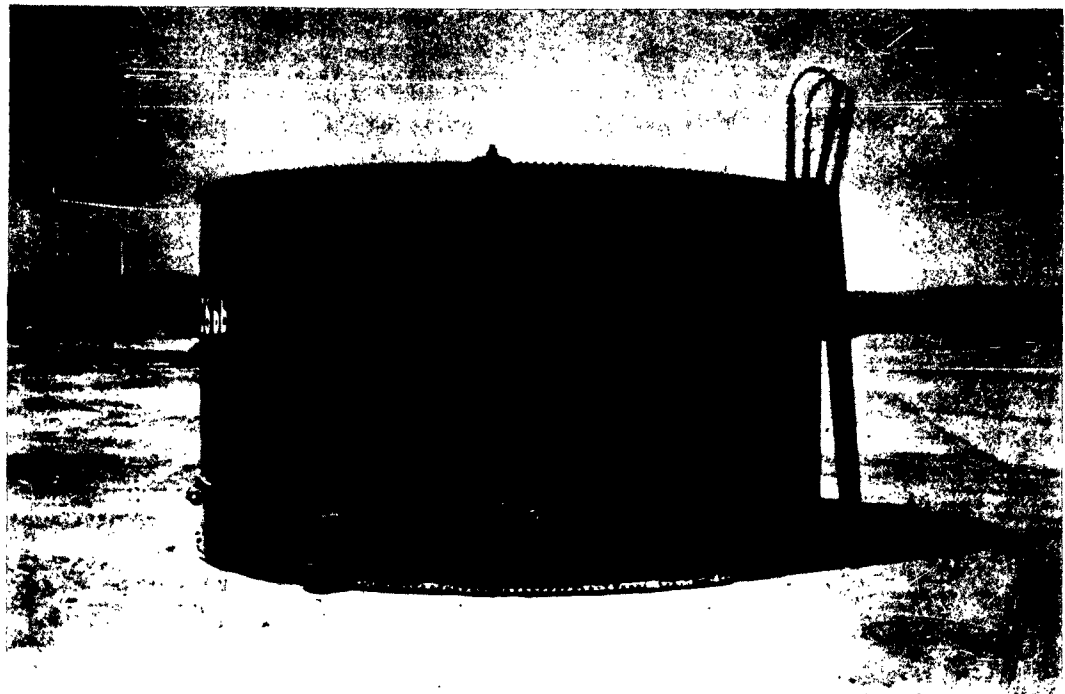
Figure 3.2 Typical view of 3.9a-1 tank, preshot.

3.2.2 Bolted Tank. This tank was a standard Army storage tank, of bolted construction, 15.5 feet in diameter and 8 feet high. The tank was set in place without special foundations in the same way as the welded tanks, and was filled with water up to a height of approximately $6\frac{1}{2}$ feet. A preshot photograph of this tank is given in Figure 3.2.
